# Manure Storage Sealing

Final Report - Project #01/37

Ron Fleming and Malcolm MacAlpine  
Ridgetown College - University of Guelph

**January 2004**  
**Prepared for:**  
**Ontario Pork**

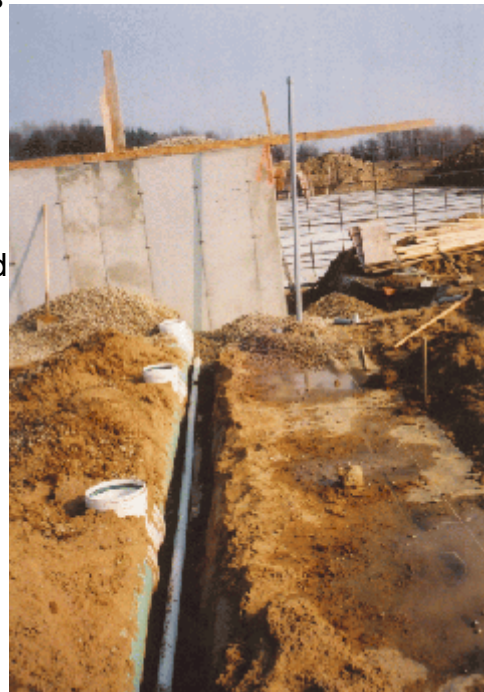
**Figure 5** Sampling pipe in trench next to pull plug transfer pipe

Figures 4, 5, 6 and 7 show the construction of the “pull plug” manure transfer system used for the weaner barn and the installation of the sample pipes. Sample pipe P1 was routed down into a gravel bed between the nursery barn and the finishing barn, about 625 mm below the manure storage grade. This gravel bed was on top of the liner, that dipped from the grade beneath the nursery barn to beneath the finishing barn manure storage, a drop of about 625 mm. It was expected this sampling pipe would pick up any liquid that leaked from the pull plug system.

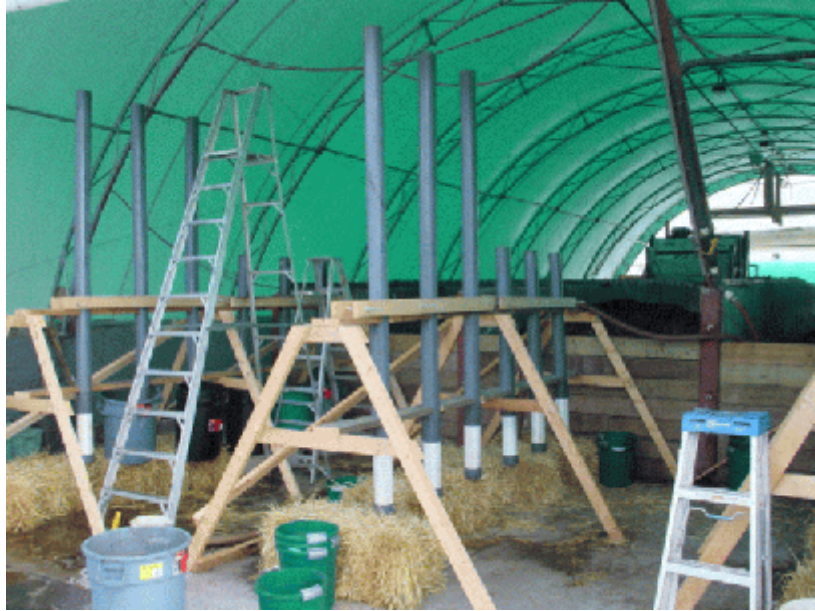
**Figure 8** Test setup, showing racks to hold pipes, pipes of 2 lengths and slotted end sections

The setup is shown in Figure 8, and a close-up of one of the slotted pipe sections is shown in Figure 9.

Racks were built to suspend the pipes upright about 30 cm above the floor. In total, there were 18 pipes used per cycle tested, with three groups of three pipes for each of the two pipe lengths. This gave three reps for each test. The complete test was then run several times, each time using a manure having a different dry matter content.

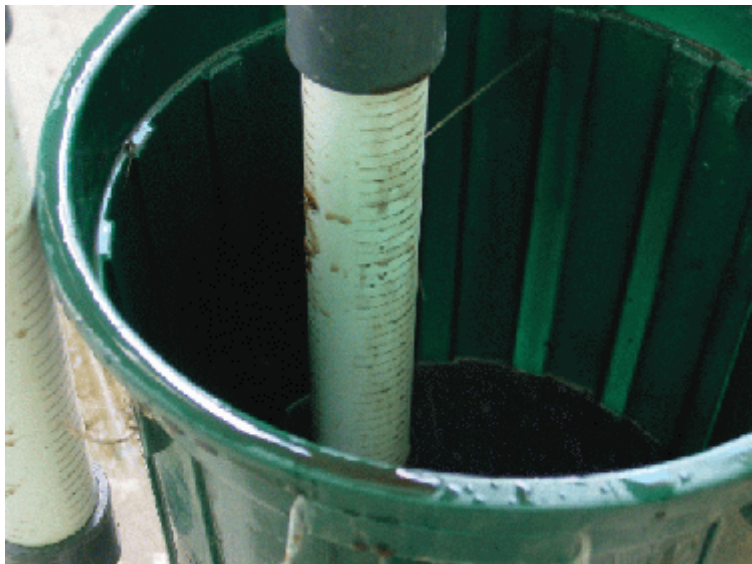
**Figure 9** Closeup of one of the pipes following partial manure sealing
